BELZONA® 1522

For Spray Applied Protection from High Temperature Erosion-Corrosion

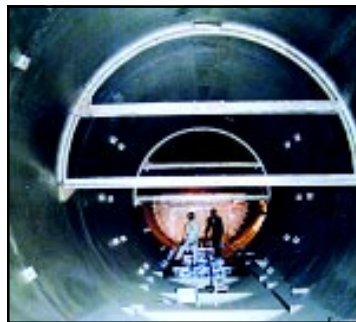
PRODUCTION SEPARATORS

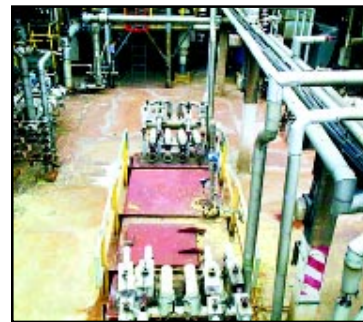
SULFUR PITS

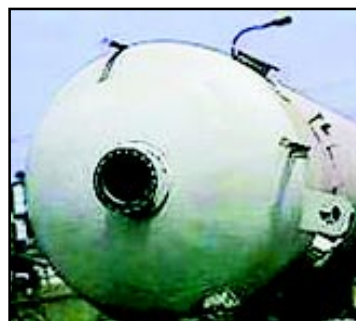
REGENERATORS

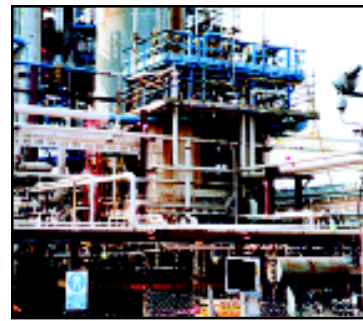
CRACKERS

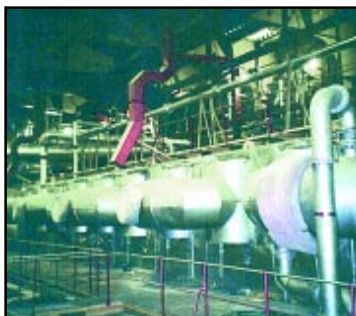
EVAPORATORS

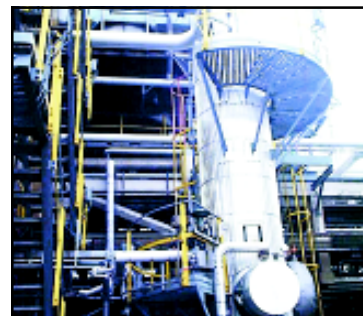
AMINE STRIPPER TOWERS

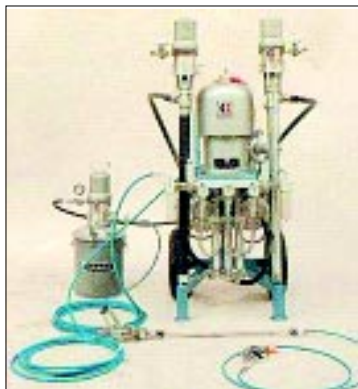
TYPICAL SPRAY EQUIPMENT FOR
BELZONA® 1522

- Belzona® 1522 is designed for application by plural airless spray.
- Applied as single coat system.
- Heat distortion temperatures significantly in excess of cure temperatures allow in-service curing.
